Plumbing

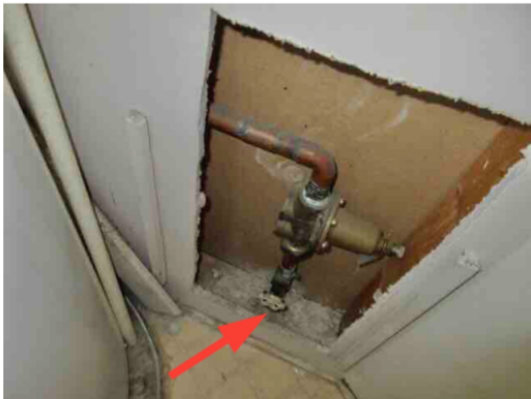
MAIN WATER SHUT-OFF:
Laundry / Mechanical Room

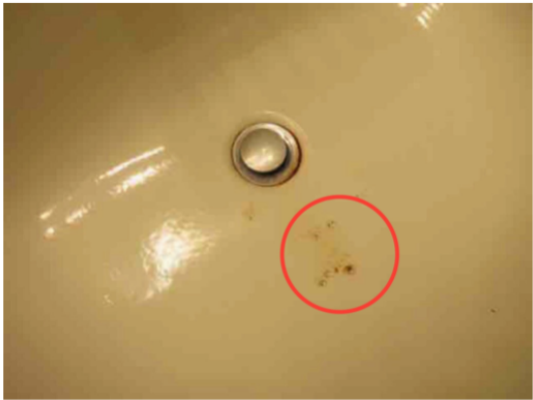
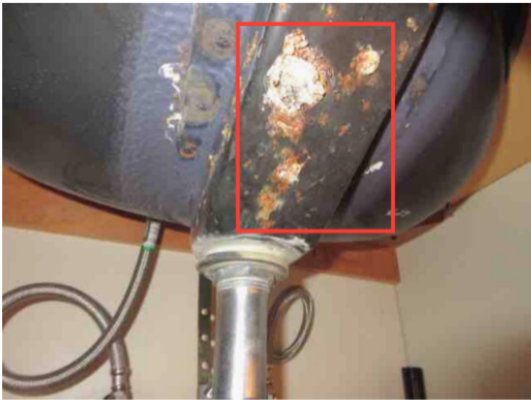
Corrosion / damage to sink. Bathroom. Risk of leakage issue. Repairs required. Within 1 year.

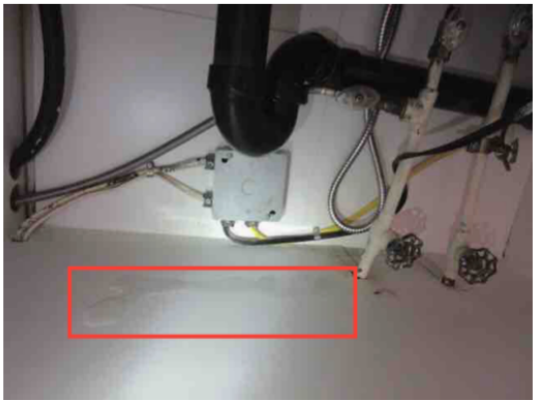
Leaking faucet. Kitchen. Water damage to contents, finishes and/or structure issue. Repairs required. Immediate.

Water dripping onto kitchen sink cabinet

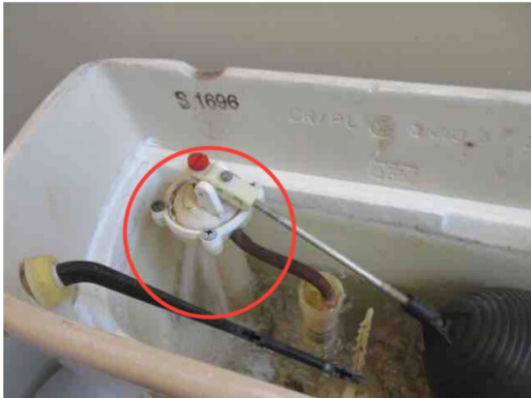
Faulty / leaking fill valve in the toilet tank. Ensuite. Component failure / not performing as intended issue. Repairs required. Within 1 year.

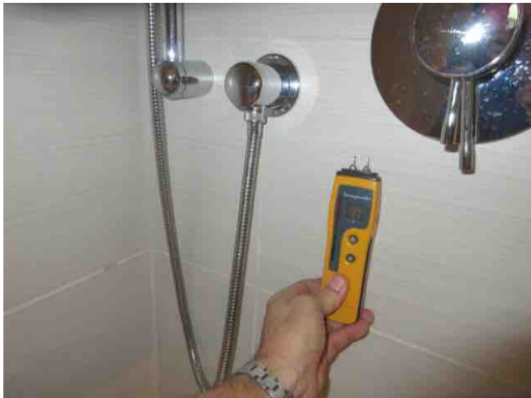
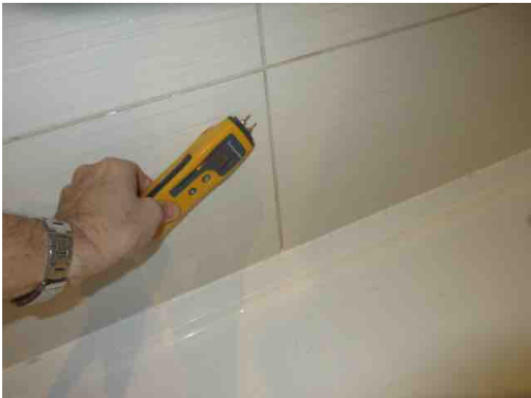
Moisture meter indicates dry readings to representative areas of tile enclosures.

Caulking and grout to bathtub and shower enclosures should be checked regularly and improved as necessary to prevent leakage and deterioration behind tile wall surfaces. Applying tile grout sealant annually is also regular maintenance.
